Conservation and Repair of Historic Buildings

Fouad Khalaf¹, Humayun Reza² and Charles Fairfield³

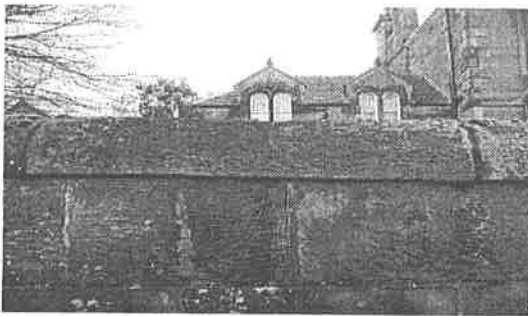
The pressure water cleaning was effective. Dirt and vegetation were removed; not all the lichens and embedded black gypsum were removed (Figs 1 to 4). Where the mortar was weak, pressure washing damaged it and the joints required re-pointing. This method was found to be cheap and effective in removing biological soiling.

Figure 1. Algae and severe soiling on the external wall

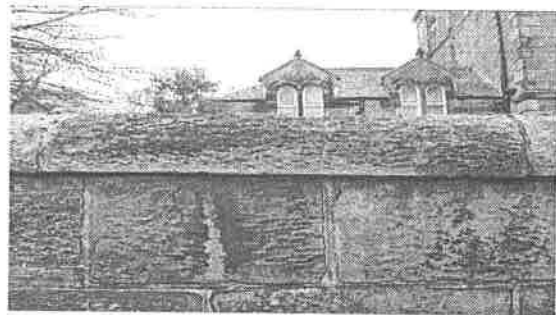
Figure 2. Algae removed: severe soiling remained

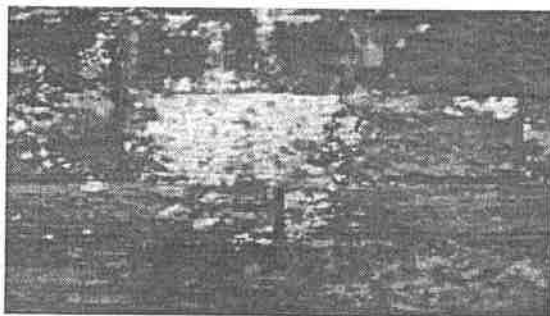
Figure 3. Lichens present on the wall before cleaning

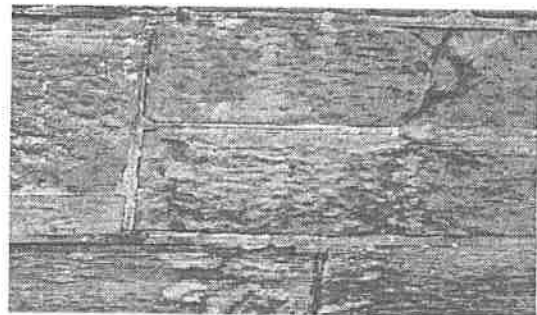
Figure 4. Traces of lichen remained after cleaning

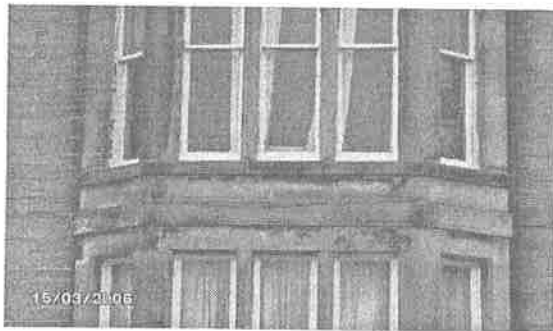
The building had suffered general soiling by atmospheric pollutants, causing window sills and various features to become blackish in colour. The sills and bay window were the worst affected areas. The front of the building was on the roadside and was more susceptible to traffic pollution than the rear. The three balconies extending from the building were also more susceptible to rainfall and various airborne pollutants. Visual inspection showed that the three balconies were heavily soiled by various atmospheric pollutants such as soot and traffic fumes. The two pyramid windows were not as badly affected as the balconies but the decorative features on them were unclear from a distance because of this soiling.

Figure 5. Soiled bay window

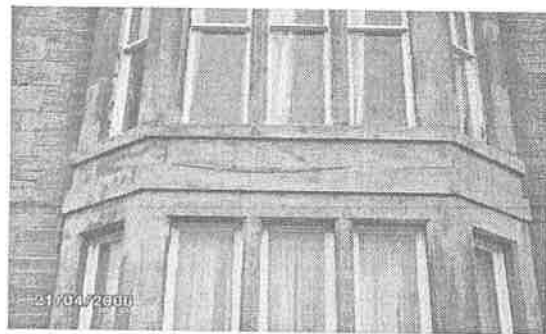
During sandblasting, biological growths and some of the black soiling were removed; however, there were still large amounts of soiled material remaining encrusted in the masonry. The results of sandblasting are shown in Figs 5 to 10.

Figure 6. Sandblasted bay window

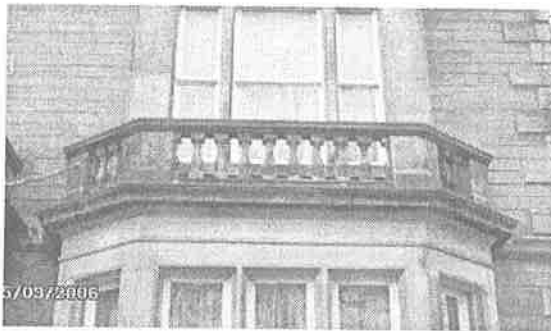
Figure 7. Soiled front balcony

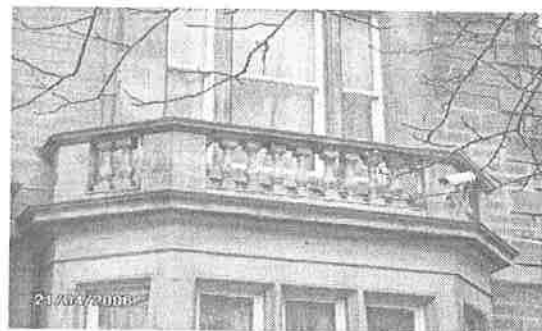
Figure 8. Sandblasted front balcony

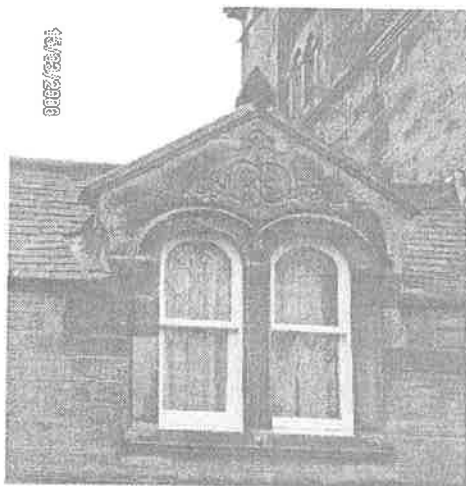
Figure 9. Soiled front window

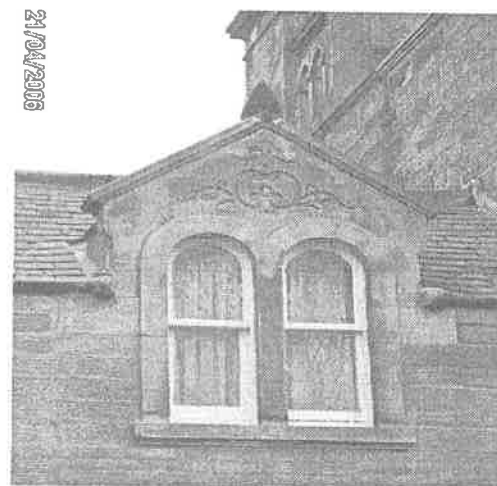
Figure 10. Sandblasted front window

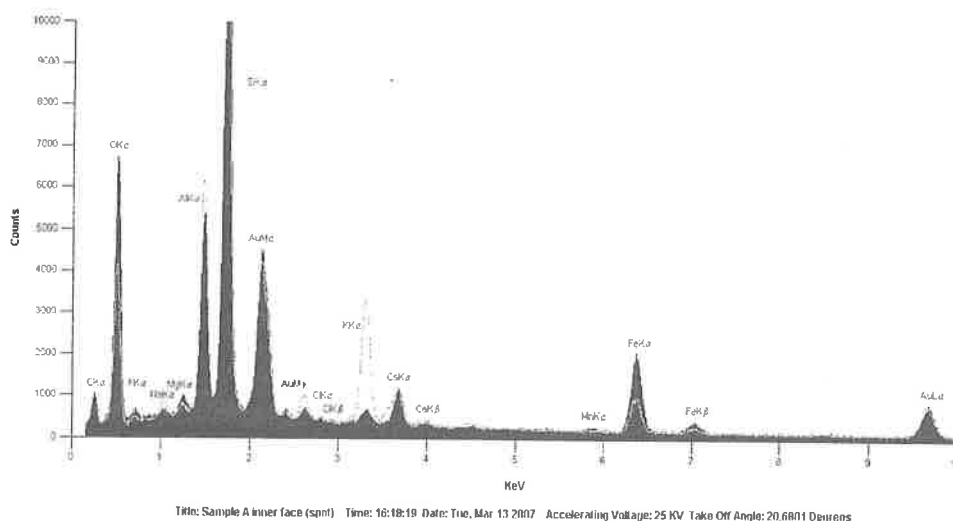
Figure 11 shows the typical EDXA results from both the surface (solid rendered plot) and 10 mm sub-surface (grey unshaded plot) analyses. As expected with sandstone the most dominant element present was silicon. The surface of the stone contained amounts of iron, carbon, and magnesium. The results suggested that the black coloured staining on the surface of the stone was non-biological and due to years of exposure to the environment, especially traffic and industrial airborne pollutants.

Figure 11. EDXA data from contaminated sandstone: surface (solid) and 10 mm sub-surface (grey)

Of interest, and as yet unexplained, is the potassium $K\alpha$ transition observed in the sub-surface spot EDXA data at 3.3 keV which was barely present in the surface, more contaminated, sample. Also of note, is the presence of the contaminant elements in the sub-surface sample, albeit to a lesser extent, which would suggest prolonged exposure has allowed pollution to penetrate the sandstone to 10 mm depth.
