EVALUATION OF EFFICIENCY OF AIR ABRASIVE CLEANING ON OLD MASONRY BUILDINGS USING GREYSCALE IMAGING ANALYSIS

KEYWORDS: Historic building, Masonry stone, Abrasive, Air abrasive cleaning, Greyscale, Cleanness.

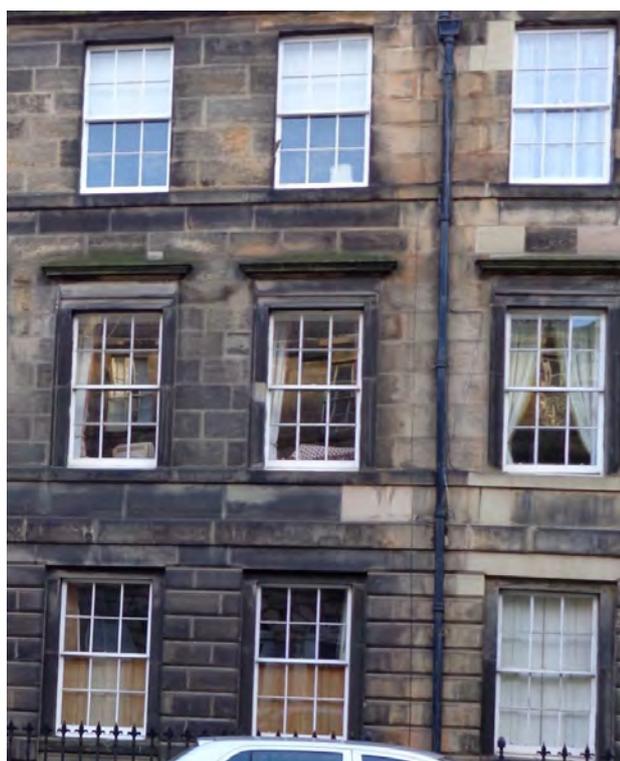
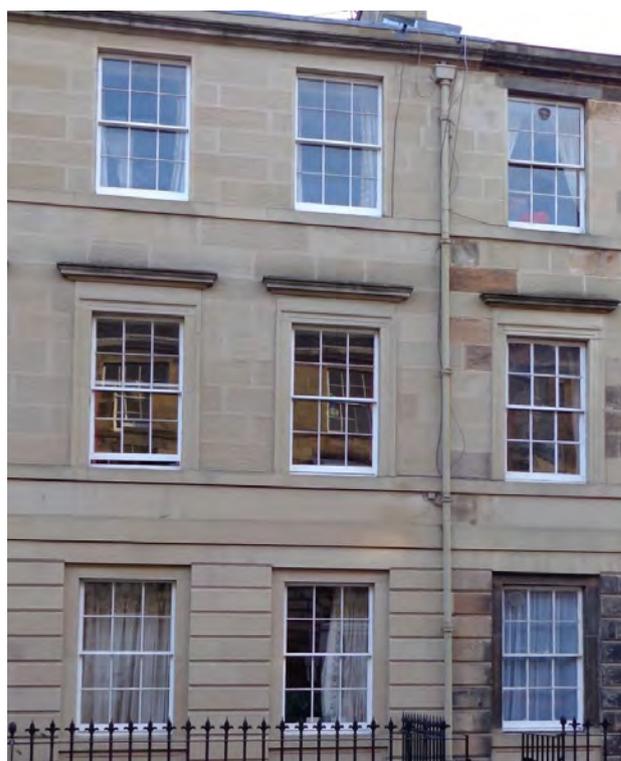
(a) Original dirty stonework façade

(b) Fully cleaned stonework façade

Fig. 1 A listed building in Edinburgh with original dirty and cleaned stonework.

Historic buildings which were normally built up with masonry stones are precious finite assets and powerful reminders for future generations of the work and way of life of earlier cultures and civilisations. The cleaning and restoration of these historic buildings is a crucial strategy in maintaining the aesthetic appearance, integrity and quality of the fine art, construction method and architecture of previous civilisations. Stone cleaning is one of the most noticeable changes a building can be subjected to. Stone cleaning has been dated back for over 40 years, peaking in the 1970s and 80s and growing into a multimillion pound industry (Laing & Urquhart, 1997; Ball et al, 2000; Ball, 2002; Feilden, 2003). At the time, the cleaning was inappropriately aggressive, causing damage to many building façades (Andrew et al, 1994; Ashurst, 1994a, 1994b; Verhoef, 1988; Young, 2002). Inappropriately selected methods of cleaning or right methods performed by unskilled operatives can lead to permanent damage to building façades. Fig. 1 shows a historic building in Edinburgh with original dirty and cleaned stonework façades.

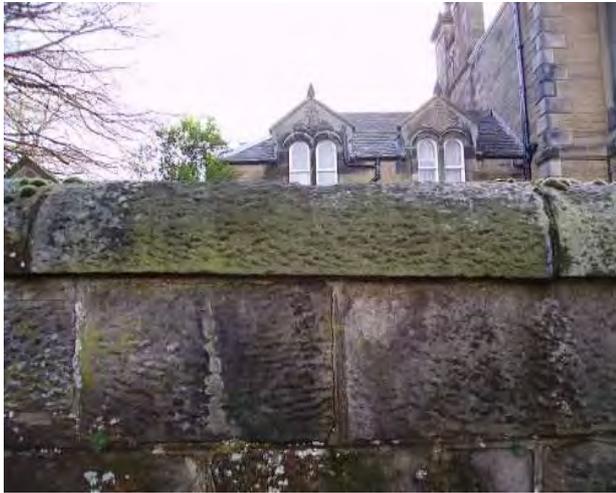
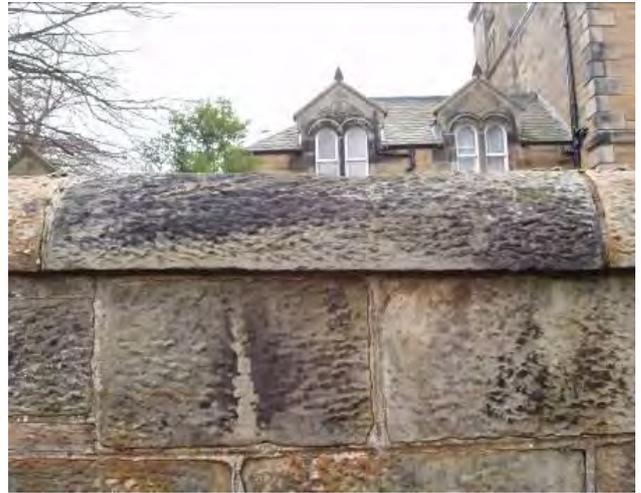
(a) Before cleaning: algae and severe soiling on the external wall

(b) After cleaning: algae removed but severe soiling still present

Fig. 2 A typical masonry stone wall before and after cleaning.

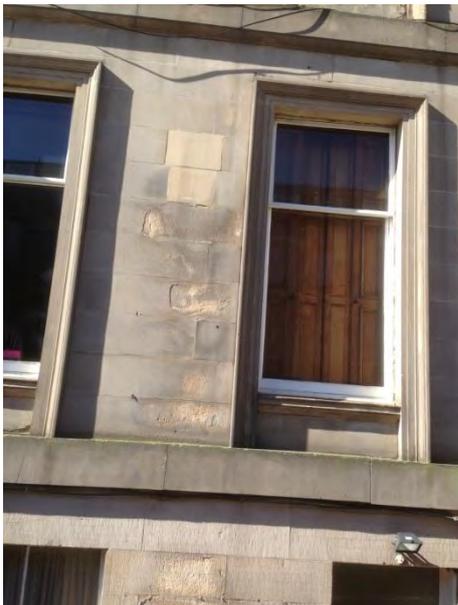
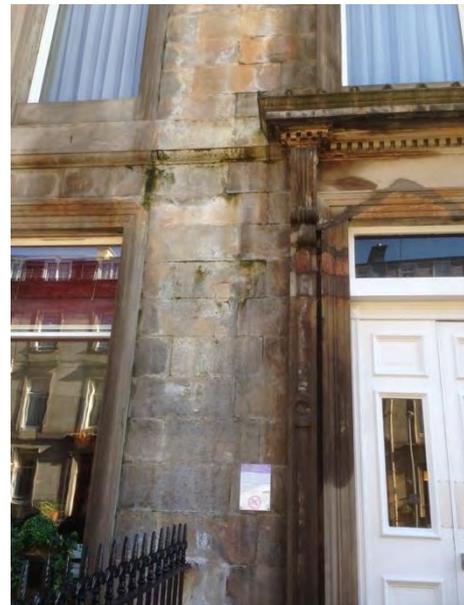
(a) On the upper storey external wall

(b) On the lower storey external wall

Fig. 3 Damages caused by chemical cleaning on the masonry stone walls.

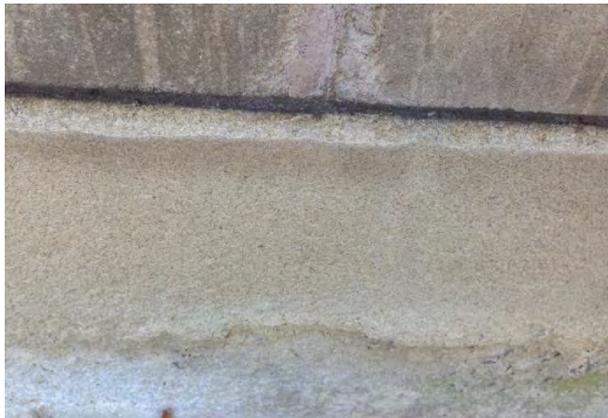
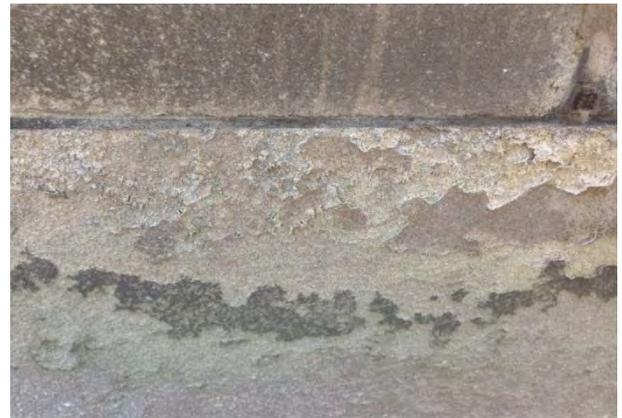
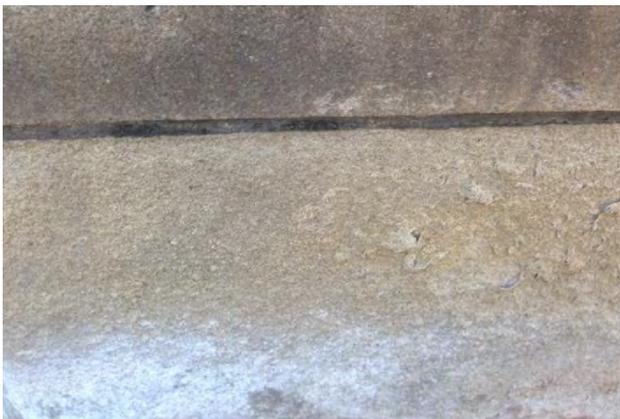
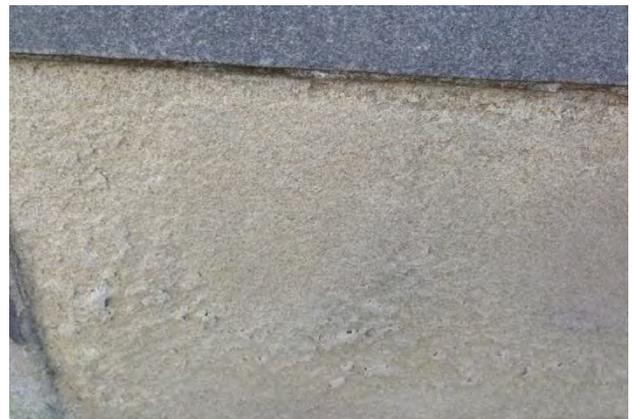
Fig. 4 Damages caused by chemical cleaning on the masonry stone surfaces.

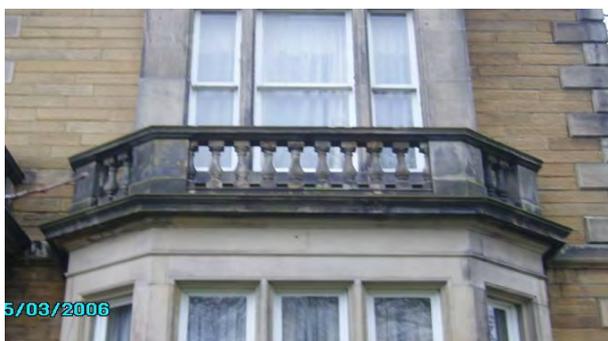
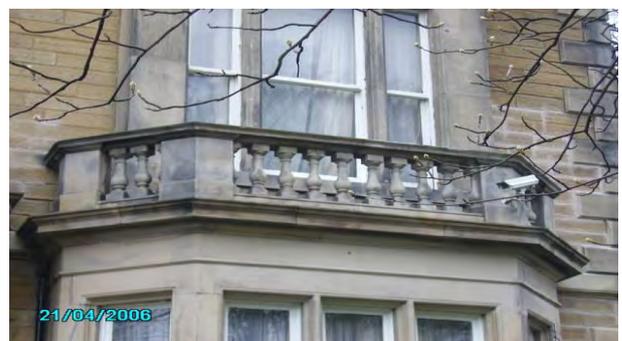
Fig. 5 Masonry stone balcony before and after air abrasive cleaning with slag.

building façade. It is very time-consuming and expensive to use on historic masonry buildings. It is desirable for heavy soiling as long as it does not cause harm to the fragile and friable fabric of the building. Abrasive cleaning is a quick method and is therefore usually considered for large areas of metals or masonries which have few design features. The most commonly used system is the air pressure blast equipment. Typical nozzle pressures range from 0.02 kPa to 14.0 kPa. Compressed air is fed to a pressure pot containing the abrasive and the mixture travels along a hose to a blasting gun. An alternative system to the pressure pot is the venture system „suction gun“. This is operated by a trigger which is easily controlled by an instant response to the operator requirement. Figs. 5 and 6 illustrate the balcony and wall around the windows of a listed sandstone building in Edinburgh before and after air abrasive cleaning with slag.

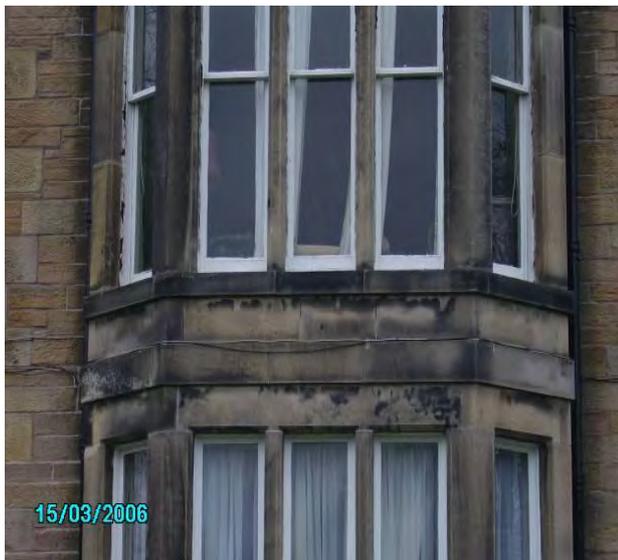
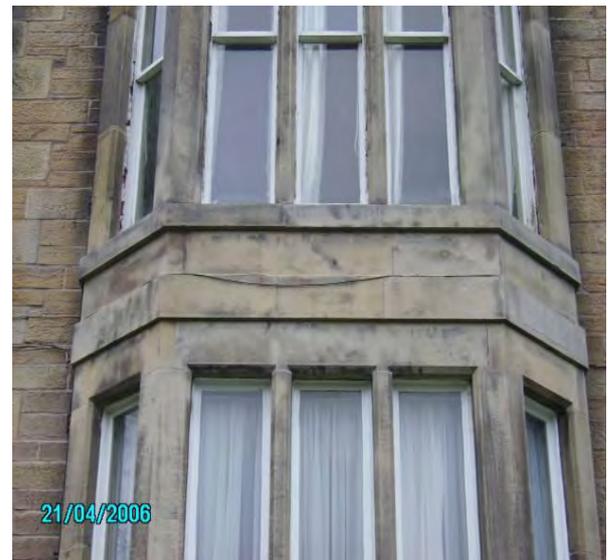
Fig. 6 Masonry stone wall around the windows before and after air abrasive cleaning with slag.

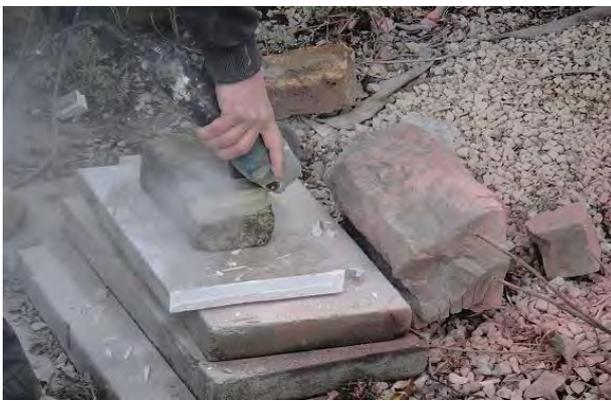
Fig. 7 Cutting samples from original stones

All five types of masonry stones were selected from those used for masonry buildings and exposed to open environmental conditions for decades with large amounts of heavy soiling and decay existing on the façades. The samples were cut into the dimensions of 50 mm × 50 mm × 25 mm from the original masonry stones and bricks using a diamond saw (see Fig. 7). The exposed surfaces of the stone samples were then cleaned to different levels with each abrasive in turn. Here an abrasive cleaning system selected included an air compressor, shot blasting cabinet and nozzle (see Fig. 8). Fig. 9 shows all five types of masonry stone samples used for greyscale imaging analysis at different cleaning stages.

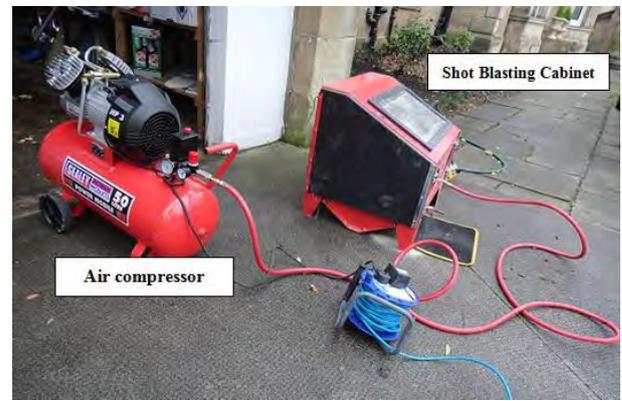
Fig. 8 The abrasive cleaning system

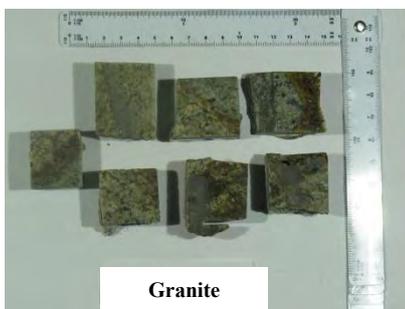
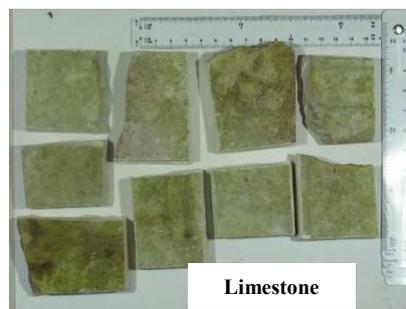
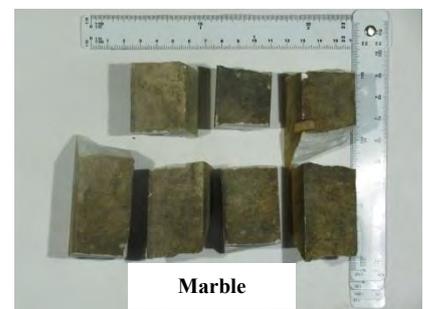
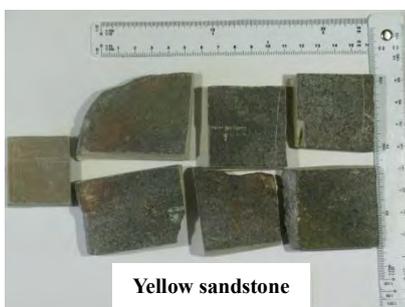
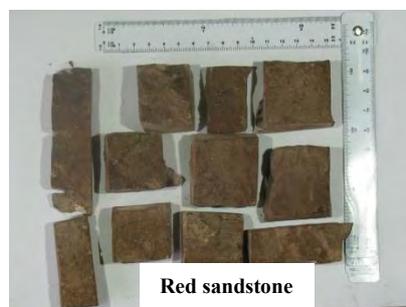
Fig. 9 Masonry stone samples for greyscale imaging analysis

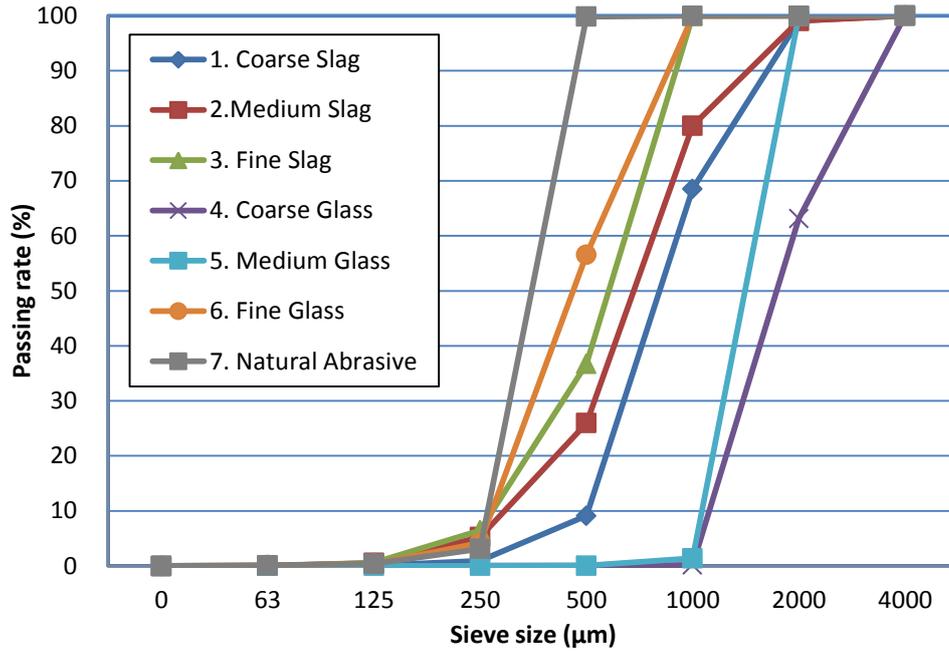
Fig. 10 Sieve test results before the impact tests for all abrasives.

From the sieve tests, the fineness moduli (FM_{pre}) of all seven abrasives were obtained (CRD, 1980; Neville, 1995) and are also listed in Table 2, which shows that coarse recycled glass is the coarsest with $FM = 6.37$, natural abrasive is the finest with $FM = 3.97$, and the rest lie in-between with $FM = 4.39$ to 5.98 . Slag abrasives are the heaviest and toughest and are followed by glass abrasives, with natural abrasive being the lightest and softest. Impact tests were also conducted on all seven abrasives (BSI, 2012), and the corresponding FM values (FM_{post}) were measured and listed in Table 2. In general, all FM values decreased after the impact tests due to finer particles produced during the tests. Natural abrasive sustained the largest drop in FM , followed by recycled glass abrasives; while slag abrasive sustained the least drop. This confirms that natural abrasive was the softest and slag abrasives were the hardest, with glass abrasives in-between. Fig. 10 illustrates the sieve test results, percentage passing rate versus sieve size, before the impact tests for all seven abrasives. Coarse glass was the coarsest abrasive, followed by medium glass and coarse slag, while natural abrasive was the finest abrasive, followed by fine glass and fine slag, with the rest in-between, the same as assessed using the fineness modulus.

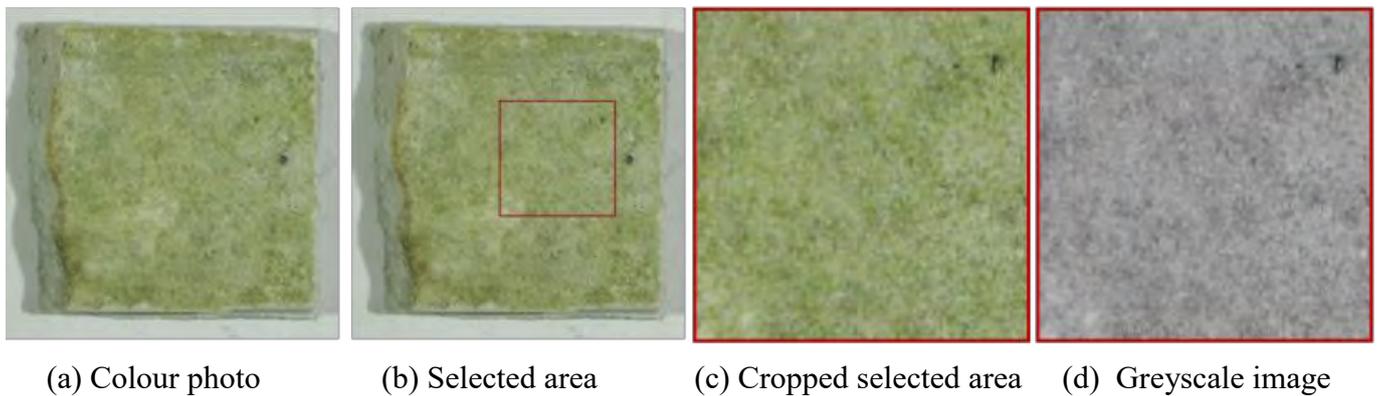
Fig. 13 Four steps for processing the image photos for limestone cleaned with fine slag.

There would be four separate steps next. The original images were scaled and orientated. An area inside was selected by drawing a red frame on the image, which was then cropped. Finally, the cropped area was converted into the greyscale image. Fig. 13 shows a typical example of this procedure, which was then applied to all the images of 35 stone samples at different cleaning stages.

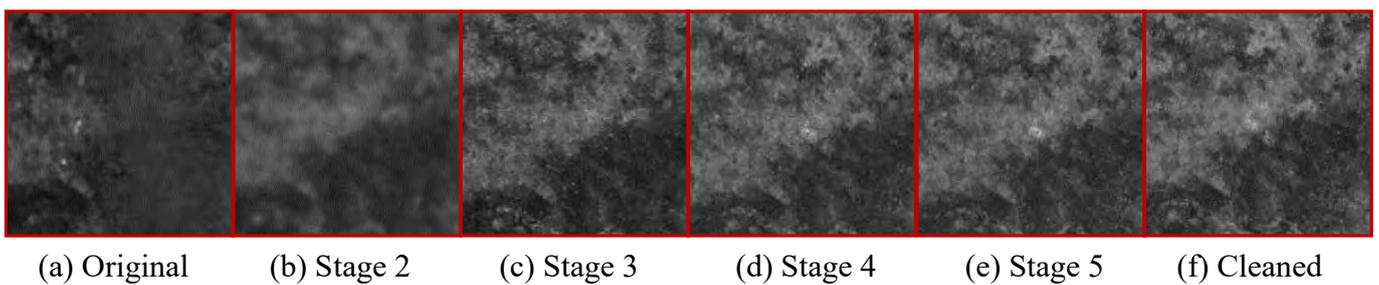
Fig. 14 Greyscale images of granite cleaned with fine glass at cleaning stages 1 to 6.

Figs. 14 to 18 show the greyscale images of all masonry stone samples cleaned with either slag or glass abrasives at different cleaning stages, respectively. In these greyscale image photos, the first images show the original dirty surfaces and the last images show the fully cleaned surfaces. From each image the average greyscale value and standard deviation were obtained using Adobe Photoshop 6. All five sets of greyscale images indicate that the stone surfaces became gradually brighter with the progress of cleaning.

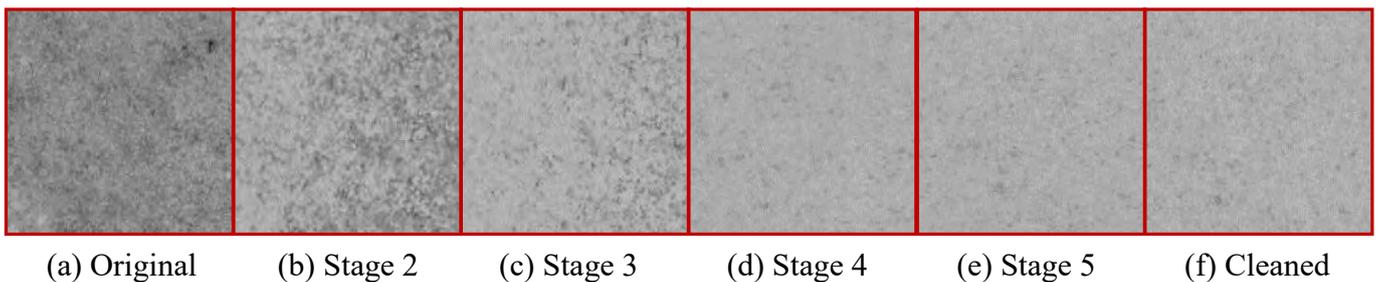
Fig. 15 Greyscale images of limestone cleaned with fine slag at cleaning stages 1 to 6.

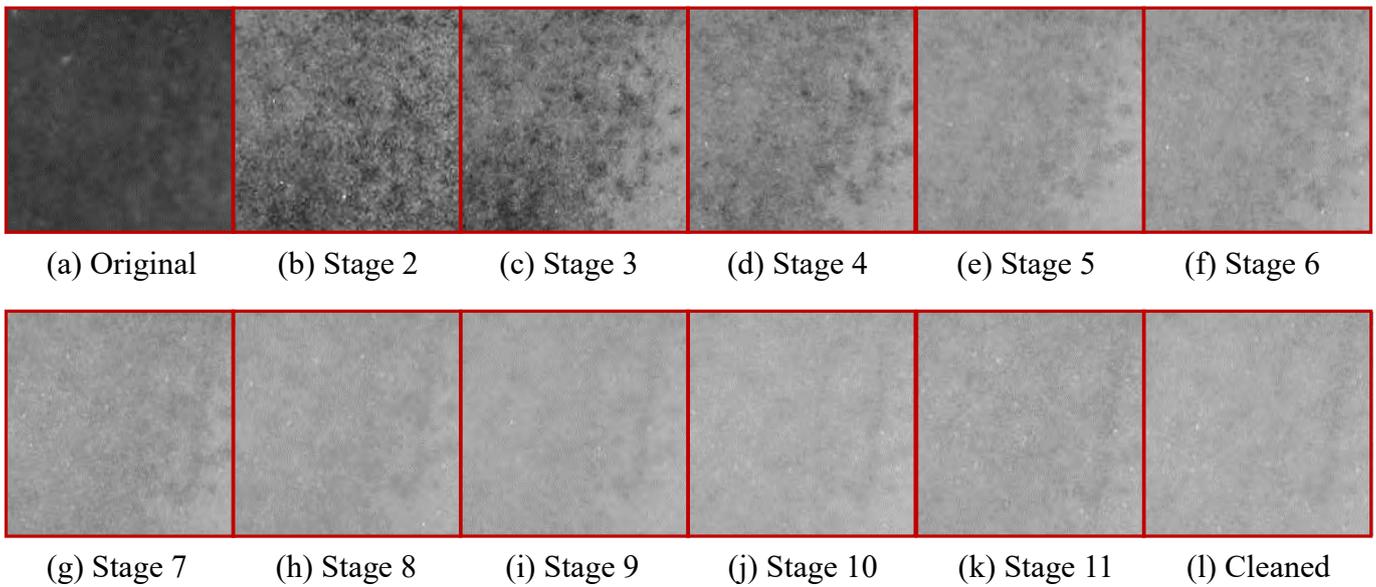
Fig. 16 Greyscale images of marble cleaned with fine glass at cleaning stages 1 to 12.

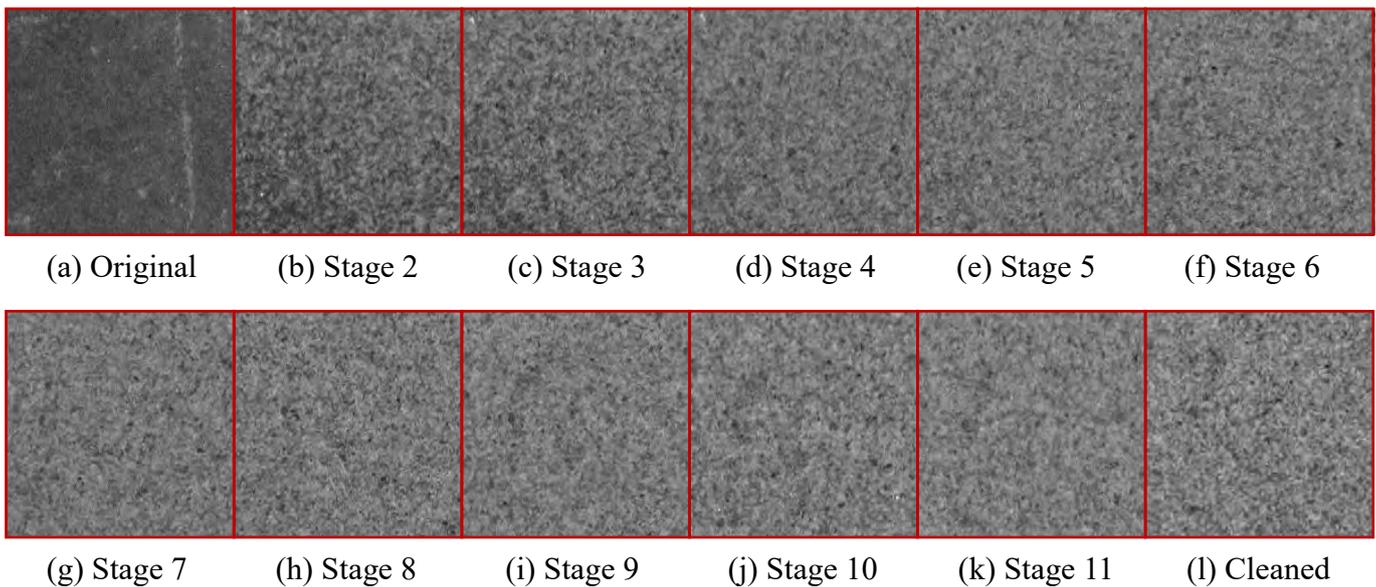
Fig. 17 Greyscale images of yellow sandstone cleaned with coarse slag at cleaning stages 1 to 12.

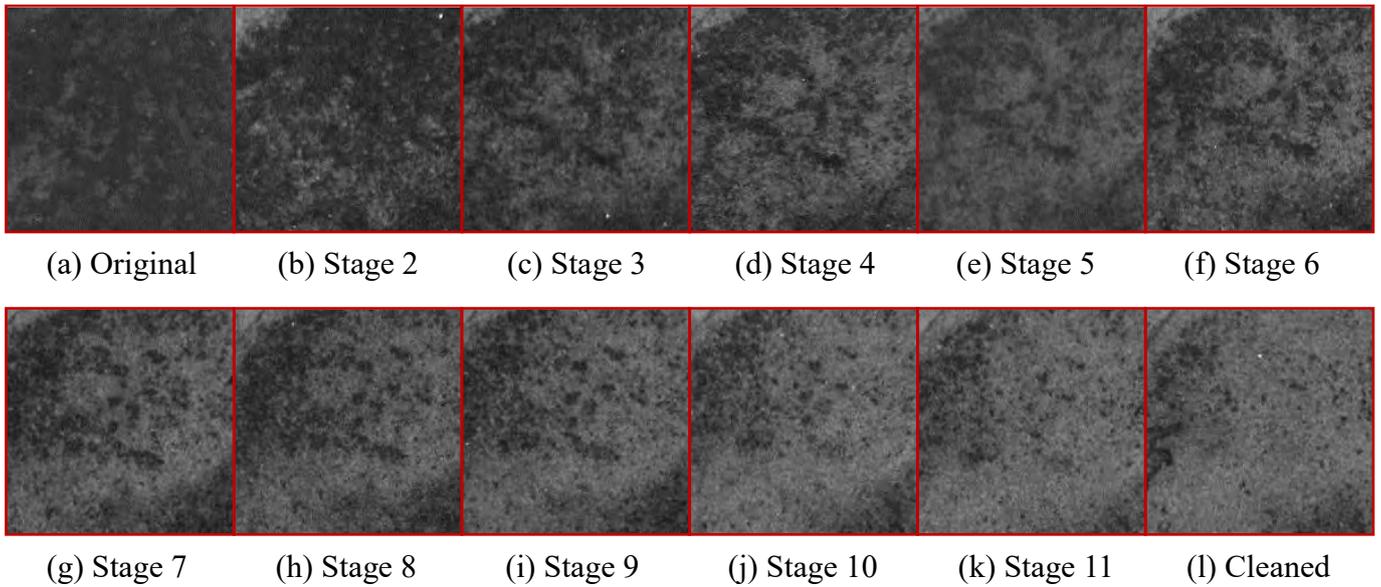
Fig. 18 Greyscale images of red sandstone cleaned with fine glass at cleaning stages 1 to 12.

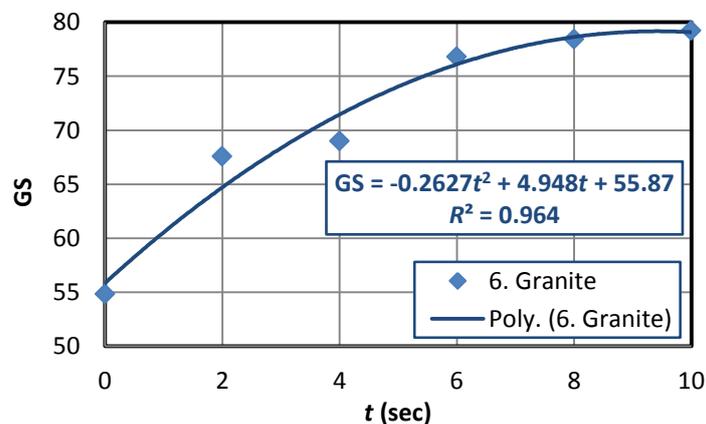
Fig. 19 Greyscale versus cleaning time for granite cleaned with fine glass.

Figs. 19 to 23 show the relationships between the greyscale GS and the cleaning time t for the above mentioned five types of masonry stones. Fig. 19 illustrates that a parabola well reflects the increasing trend of greyscale with the cleaning time for granite cleaned with fine glass. The data and the parabola almost coincide since the R^2 -value is equal to 0.964 which is very close to 1.0. Greyscale increased with the cleaning time from $GS = 54.83$ before cleaning at a decreasing rate and became stable at $GS = 79.24$ when the sample was fully cleaned after 10 seconds, up by 24.41 in GS or 44.5%. It seems that only 6 seconds corresponding to $GS = 76.80$ may be enough to largely clean this sample. The gap in greyscale values between the original dirty and fully cleaned states was quite big, which indicates that the surface of the original granite was very dirty. Fig. 20 shows that a parabola can represent the increasing trend of greyscale with the cleaning time for limestone cleaned with fine slag. The data and the parabola almost coincide with $R^2 = 0.965$. Greyscale increased with the cleaning time from $GS = 134.85$ before cleaning at a decreasing rate and finally became stable at $GS = 171.99$ when the sample was fully cleaned after 10 seconds, up by 37.14 in GS or 27.5%. It seems that only 4 seconds corresponding to $GS = 168.86$ may be enough for almost fully cleaning this sample. The gap in greyscale values between the original dirty and fully cleaned states was not quite big, which indicates that the surface of the original granite was not very dirty.

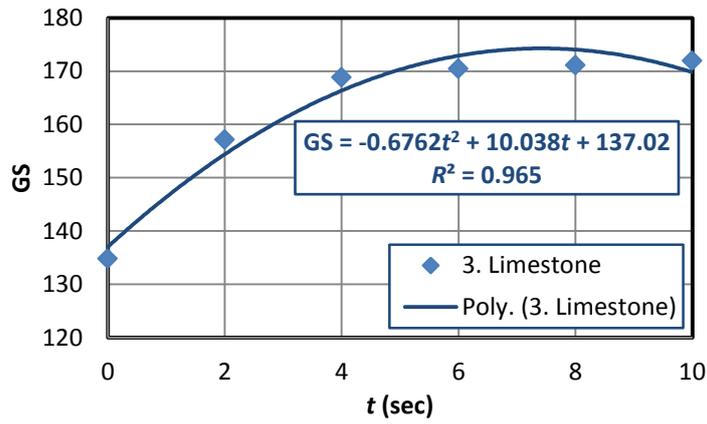
Fig. 20 Greyscale versus cleaning time for limestone cleaned with fine slag

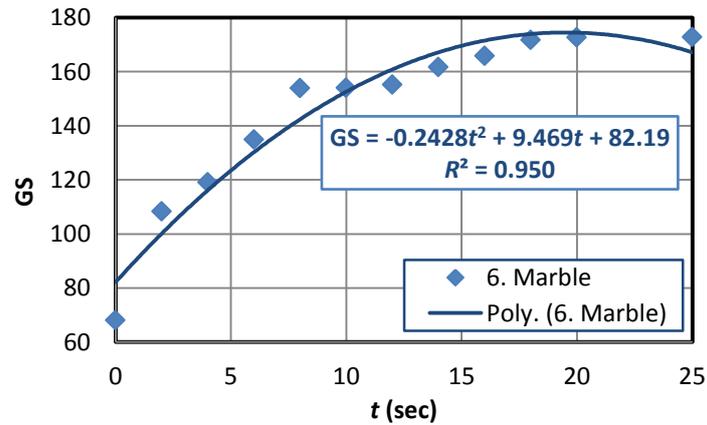
Fig. 21 Greyscale versus cleaning time for marble cleaned with fine glass.

Fig. 21 shows that a parabola well reflects the increasing trend of greyscale with the cleaning time for marble cleaned with fine glass. The data and the parabola almost coincide with $R^2 = 0.950$. Greyscale increased with the cleaning time from $GS = 68.09$ before cleaning at a decreasing rate and finally became stable at $GS = 172.81$ when the sample was fully cleaned after 25 seconds, up by 104.72 in GS or 153.8%. It seems that it would take about 18 seconds, corresponding to $GS = 171.85$, to almost fully clean this sample. The gap in greyscale values between the original dirty and fully cleaned states was huge, indicating that the surface of the original marble was extremely dirty. Fig. 22 illustrates that a parabola can represent the increasing trend of greyscale with the cleaning time for yellow sandstone cleaned with coarse slag, with $R^2 = 0.827$. Greyscale increased with the cleaning time from $GS = 81.14$ before cleaning at a decreasing rate and finally became stable at $GS = 124.51$ when the sample was fully cleaned after 180 seconds, up by 43.37 in GS or 53.5%. It seems that it would take about 100 seconds, corresponding to $GS = 120.23$, to almost fully clean this sample. The gap in greyscale values between the original dirty and fully cleaned states was reasonably large, which indicates that the surface of the original yellow sandstone was quite dirty. Finally, Fig. 23 shows that a parabola well matches the increasing trend of greyscale with the cleaning time for red sandstone cleaned with fine glass. The data and the parabola almost coincide with $R^2 = 0.959$. Greyscale increased with the cleaning time from $GS = 58.56$ before cleaning at a decreasing rate and finally became stable at $GS = 93.84$ when the sample was fully cleaned after 80 seconds, up by 35.28 or 60.2%. It seems that 50 seconds, corresponding to $GS = 90.94$, may be enough for almost fully cleaning this sample. The gap in greyscale values between the original dirty and fully cleaned states was huge, indicating that the surface of the original red sandstone was very dirty.

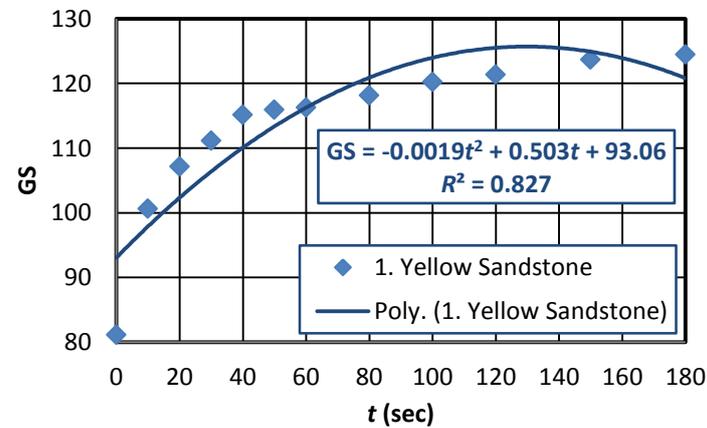
Fig. 22 Greyscale versus cleaning time for yellow sandstone cleaned with coarse slag.

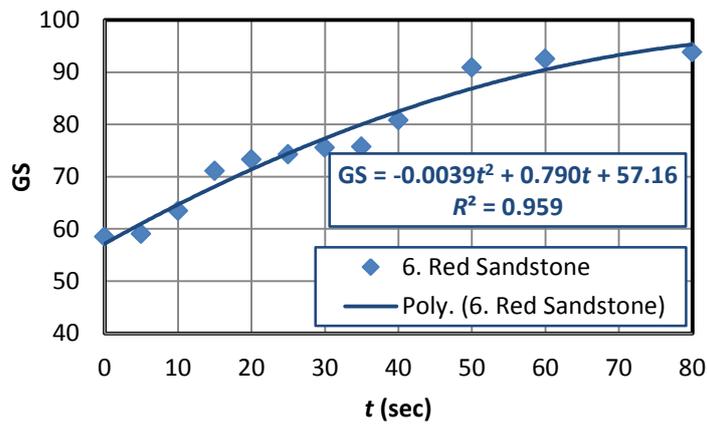
Fig. 23 Greyscale versus cleaning time for red sandstone cleaned with fine glass.
