Investigations of Physical and Chemical Characteristics of Masonry Stones and Bricks during Building Cleaning: Part 2. Chemical Testing

Binsheng Zhang¹, Humayun Reza², Shiyan Gu² and Naren Gupta²

Abstract: This series of study focused on analysing and assessing the changes of the physical and chemical characteristics of the stone surfaces during the sandblasting cleaning process by conducting various physical and chemical tests. Seven masonry stones and bricks were adopted, including yellow sandstone, red sandstone, limestone, marble, granite, white clay brick and yellow clay brick. The chemical investigations included the micrographing of the stone façade and the analysis of the chemical elements and compounds on four of the seven stones and bricks before and after the cleaning using the Scanning Electron Microscope (SEM) and Energy-Dispersive X-ray Spectroscopy (EDX) techniques. In general, the chemical properties were found to vary largely during the building cleaning. The chemical tests showed that the chemical elements and compounds on the stone façade significantly varied after long term exposures to the atmosphere, mainly due to the soiling on the building façade caused by

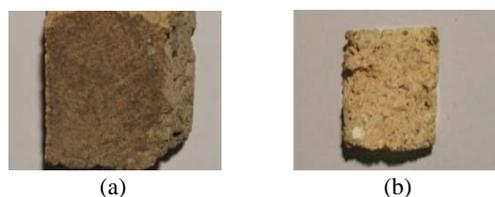
Fig. 1 Yellow clay brick samples for SEM and EDX testing. (a) fully dirty sample and (b) fully clean sample.

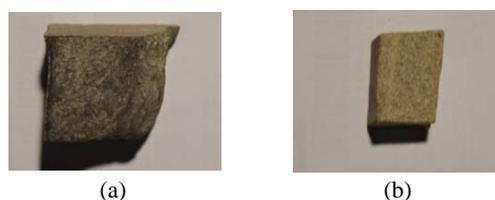
Fig. 2 Yellow sandstone samples for SEM and EDX testing: (a) fully dirty sample and (b) fully clean sample.

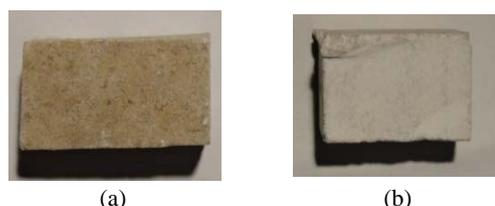
Fig. 3 Limestone samples for SEM and EDX testing: (a) fully dirty sample and (b) fully clean sample.

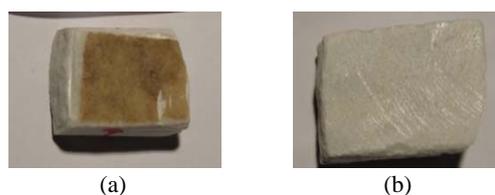
Fig. 4 Marble samples for SEM and EDX testing: (a) fully dirty sample and (b) fully clean sample.

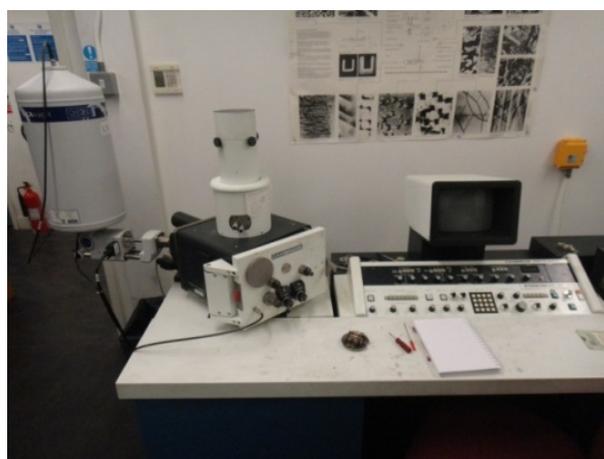
Fig. 5 The SEM and EDX instrument.

In this study, the chemical analysis was conducted by using the instrument with the combined SEM and EDX, as shown in Fig. 5. The instrument used in this study was the SEM LEO S 430 I, UK, coupled with ISIS EDD detector from Oxford Instrument, UK.

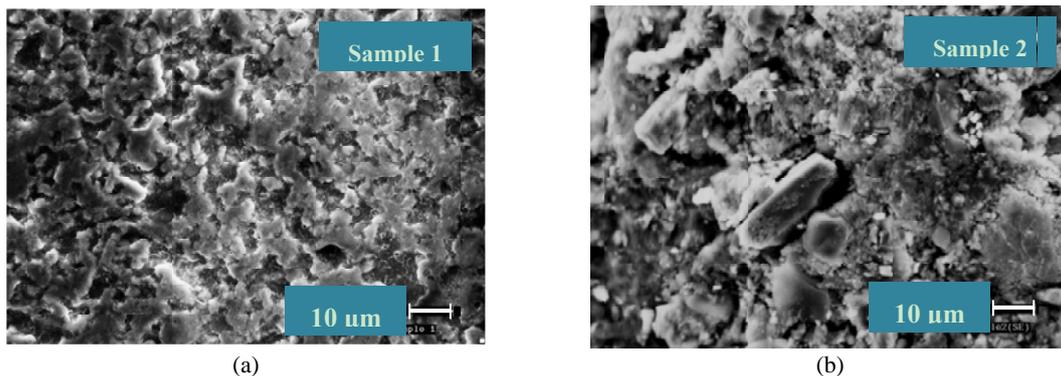
Fig. 6 Typical micrographs for the yellow clay brick samples. (a) Original dirty surface (Sample 1(6)) and (b) fully clean surface (Sample 2(5)).

Fig. 6 presents typical micrographs of the surface structures of the original dirty and fully clean yellow clay brick samples. Fig. 6a shows that the soiling existed loosely on the dirty surface, and there were no obvious interactions between the particles. Fig. 6b shows that the fully clean surface was more crystalline and interactive. The numbers in the brackets represent

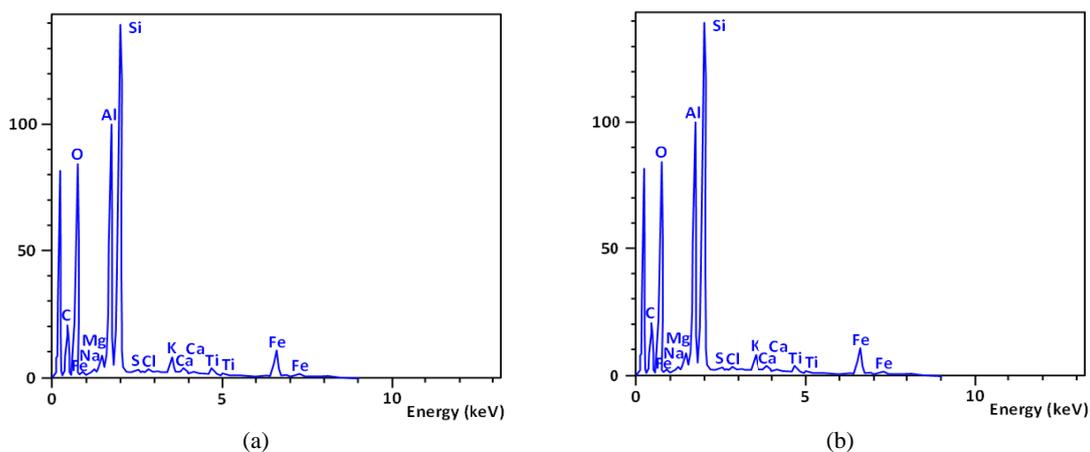
Fig. 7 Typical spectrum diagrams for the yellow clay brick samples. (a) Original dirty surface (Sample 1(5)) and (b) fully clean surface (Sample 2(4))

Fig. 7 shows typical chemical spectrum diagrams on the original dirty and fully clean surfaces of the yellow clay brick samples. Common chemical elements found to exist on both dirty and clean surfaces included C, O, Na, Mg, Al, Si, S, Cl, K, Ca, Ti and Fe, but the peak values were remarkably different for some elements, e.g. C, Al, Si, S, Ca and Fe, which indicates that the amounts of these elements varied during the cleaning process.

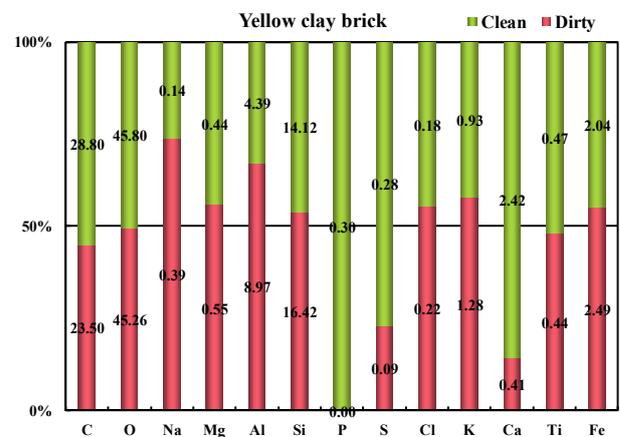
Fig. 8 Chemical elements on the surfaces of the original dirty and fully clean yellow clay brick samples.

Fig. 8 shows the quantities of the chemical elements detected on the original dirty and fully clean surfaces of the yellow clay brick samples. The main chemical elements in the original yellow clay brick were C, O, Si and Al at 23.50%, 45.26%, 16.42% and 8.97%, respectively, which indicates that the main chemical compounds in the yellow clay brick were CaCO₃, SiO₂ and Al₂O₃. By viewing the 50% dividing line, it can also be seen that that C slightly increased to 28.80% after cleaning while Si and Al decreased to 14.12% and 4.39%. As the samples were coated with carbon, it is hard to quantitatively analyse the changes of C. However, the decrease in Si and Al which represent Quartz (SiO₂) and Aluminium oxide (Al₂O₃) through the cleaning process indicates that these two

compounds were formed in the original yellow clay brick. Similarly, the decrease of the rare elements in the yellow clay brick such as Mg and Fe which represent Magnesium oxide (MgO) and Iron disulfide (FeS₂) may be caused by polluting gases like O₃ and H₂S.

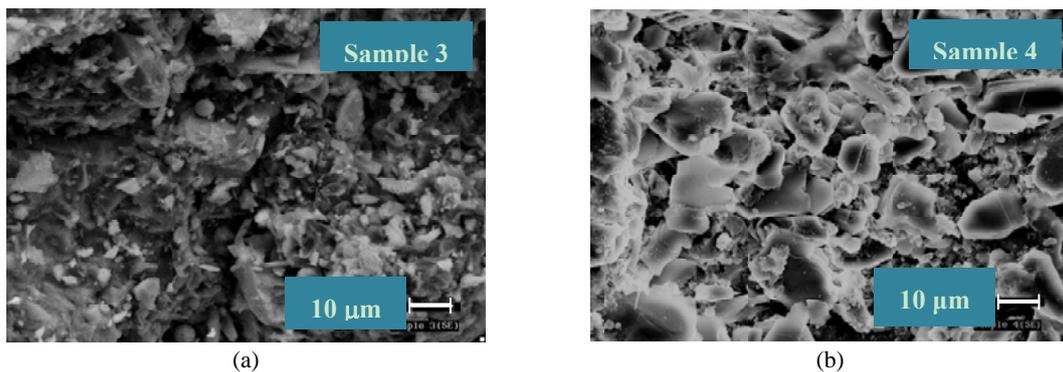
Fig. 9 Typical micrographs for the yellow sandstone samples: (a) original dirty surface (Sample 3(4)) and (b) fully clean surface (Sample 4(5)).

Fig. 9 presents typical micrographs of the surface structures of the original dirty and fully clean yellow sandstone samples. Fig. 9a shows that the soiling still loosely existed on the surface of the dirty yellow sandstone, and there were no obvious interactions between the particles. Fig. 9b shows that the surface of the fully clean yellow sandstone was remarkably crystalline and orderly.

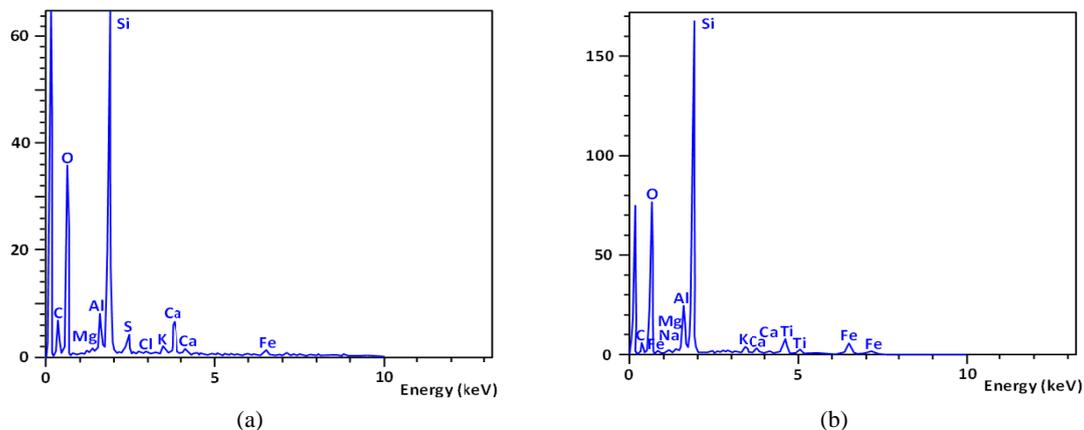
Fig. 10 Typical spectrum diagrams for the yellow sandstone sample: (a) original dirty surface (Sample 3(6)) and (b) fully clean surface (Sample 4(6)).

Fig. 10 illustrates typical chemical spectrum diagrams on the surfaces of the original dirty and fully clean yellow sandstone samples. Common

chemical elements observed on both dirty and clean surfaces included C, O, Mg, Al, Si, K, Ca and Fe, and the peak values were remarkably different for some elements, e.g. C, Al, K, S, Ca and Fe, which indicates that the amounts of these elements varied during the cleaning process. Si and Cl only existed on the original dirty surface while Na and Ti only existed on the fully clean surface.

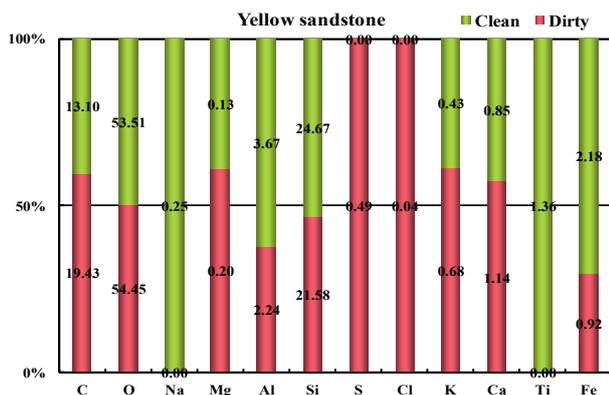
Fig. 11 Chemical elements on the surfaces of the original dirty and fully clean yellow sandstone samples.

Fig. 11 shows the quantities of the chemical elements detected on the original dirty and fully clean surfaces of the yellow sandstone samples. The main elements in the clean yellow sandstone were C, O and Si at 13.10%, 53.51% and 24.67%, respectively, and the corresponding compounds were CaCO₃ and SiO₂. By viewing the 50% dividing line, it can also be seen that the main elements in the sandstone did not change much during cleaning.

However, some metallic elements such as Na, Al, Ti and Fe which represent Albite, Aluminium oxide (Al₂O₃), Titanium (Ti) and Iron disulfide (FeS₂) largely increased after cleaning, which indicates that

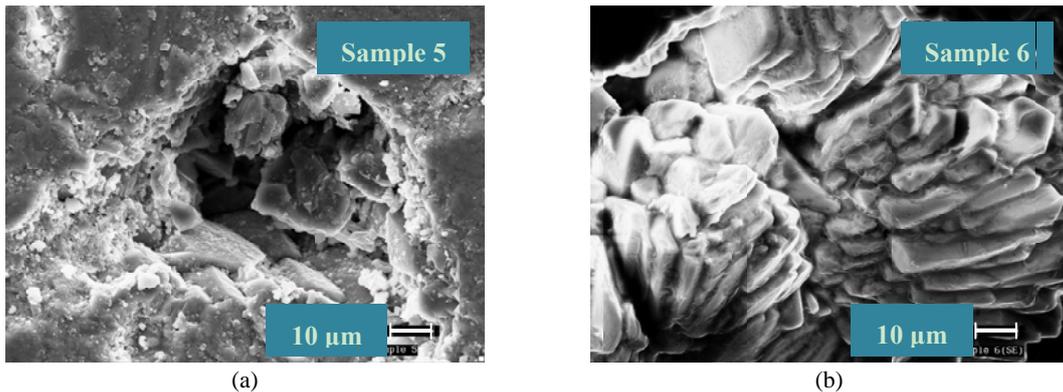
Fig. 12 Typical micrographs for the limestone samples. (a) Original dirty surface (Sample 5(2)) and Fully clean surface (Sample 6(4)).

Fig. 12 shows typical micrographs of the surface structures of the limestone samples. Fig. 12a shows that the soiling on the surface of the dirty limestone was lightly crystalline with some defects. Fig. 12b shows that the surface of the fully clean limestone was more crystalline and orderly.

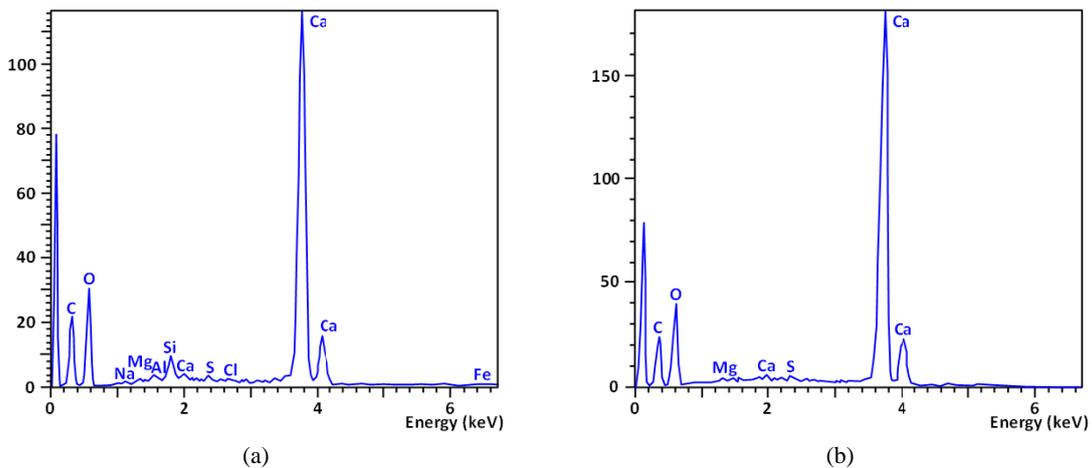
Fig. 13 Typical spectrum diagrams for the limestone samples. (a) Original dirty surface (Sample 5(6)) and (b) Fully clean surface (Sample 6(4)).

Fig. 13 illustrates typical chemical spectrum diagrams on the surfaces of the original dirty and fully clean limestone samples. Common chemical elements observed on both dirty and clean surfaces included C, O, Mg, Si and Ca, but the peak values were remarkably different for C and Ca, which indicates that the amounts of these two elements largely varied during the cleaning process. Na, Al and Si only existed on the original dirty surface.

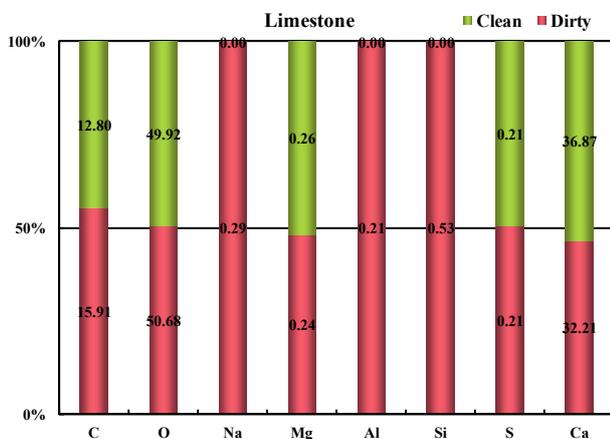
Fig. 14 Chemical elements on the surfaces of the original dirty and fully clean limestone samples.

Table 3 lists the relative amounts of the eight detected chemical elements by using the EDX for both original dirty and fully clean limestone samples. Fig. 14 shows the quantities of the chemical elements detected on the original dirty and fully clean surfaces of the limestone samples. The main chemical elements in the clean limestone were C, O and Ca at 12.80%, 49.92% and 36.87%, and the corresponding compounds were CaCO_3 , SiO_2 and Wollas. By viewing the 50% dividing line, it can also be seen that the main elements in the limestone did not change largely during the cleaning. However, some rare elements such as Na, Al and Si which represent Albite, Aluminium oxide (Al_2O_3) and Quartz (SiO_2) disappeared after cleaning, which indicates that these compounds were not the original elements of the limestone but belonged to the dirty soiling.

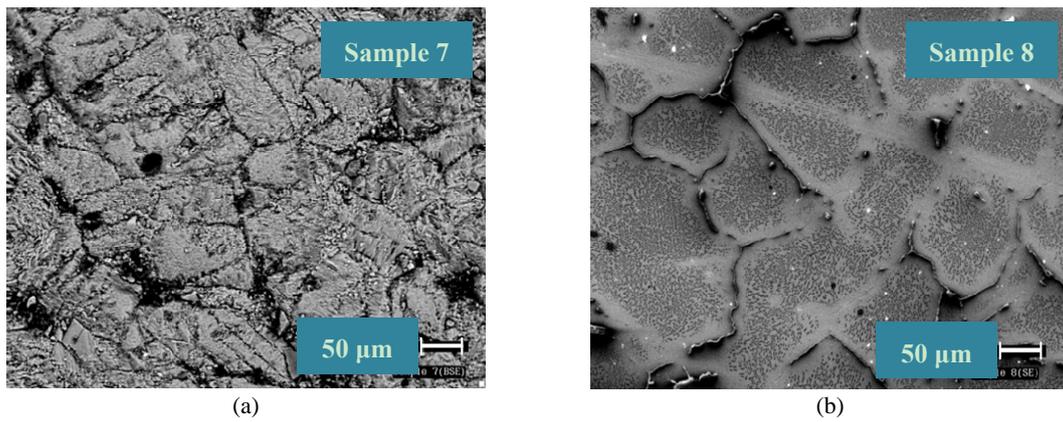
Fig. 15 Typical micrographs for the marble samples. (a) Original dirty surface (Sample 7(3)) and (b) Fully clean surface (Sample 8(5))

Fig. 15 presents typical micrographs of the surface structures of the original dirty and fully clean marble samples. Fig. 15a shows that the soiling on the surface of the dirty marble was rough and loose, while Fig. 15b shows that the surface of the fully clean marble was crystalline and orderly. Fig. 16 shows typical chemical spectrum diagrams on the surfaces of the original dirty and fully clean marble samples. Common chemical elements observed on both dirty and clean surfaces included C, O, Mg, Al, Si and Ca, but the peak values were remarkably different for C, O, Al, Si and Ca, which indicates that the amounts of these elements largely varied during the cleaning process. Na, S, Al, K and Fe only existed on the original dirty surface.

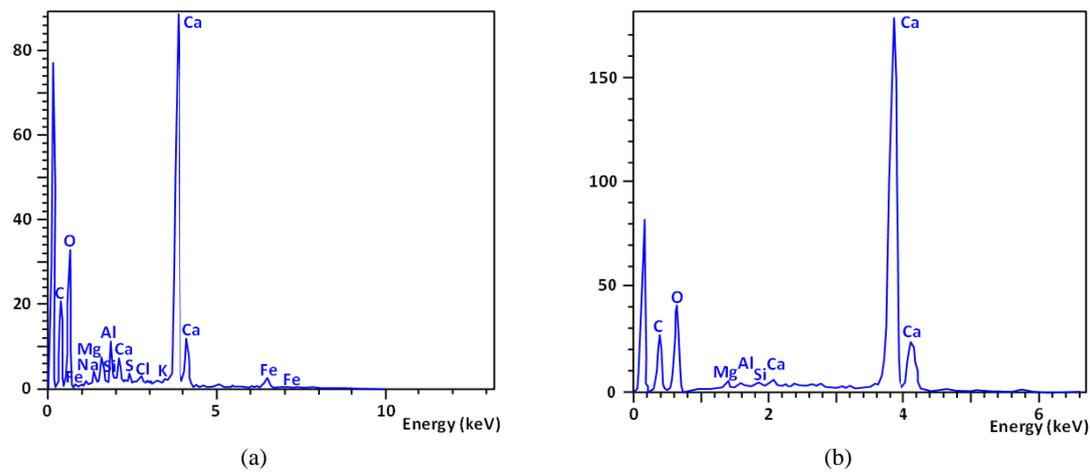
Fig. 16 Typical spectrum diagrams for the marble samples: (a) original dirty surface (Sample 7(6)) and (b) fully clean surface (Sample 8(6)).

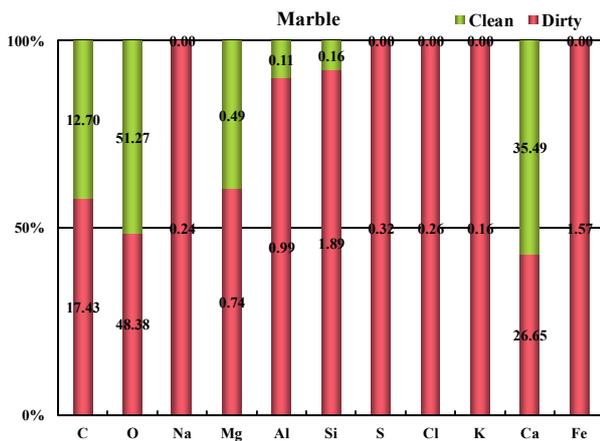
Fig. 17 Chemical elements on the surfaces of the original dirty and fully clean marble samples.

Table 4 lists the relative amounts of the eleven detected chemical elements in percentage by using the EDX for both original dirty and fully clean marble samples. Fig. 17 shows the quantities of the chemical elements detected on the original dirty and fully clean surfaces of the marble samples. The main elements in the clean marble were C, O and Ca at 12.70%, 51.27% and 35.49%, respectively, and the main compounds in the marble were CaCO₃ and Wollas.
